MISCELLANEOUS PAPER NO. 4-844

XV5A AIRCRAFT FLIGHT TESTS LANDING STRIP EVALUATIONS

September 1966

U. S. Army Engineer Waterways Experiment Station CORPS OF ENGINEERS Vicksburg, Mississippi

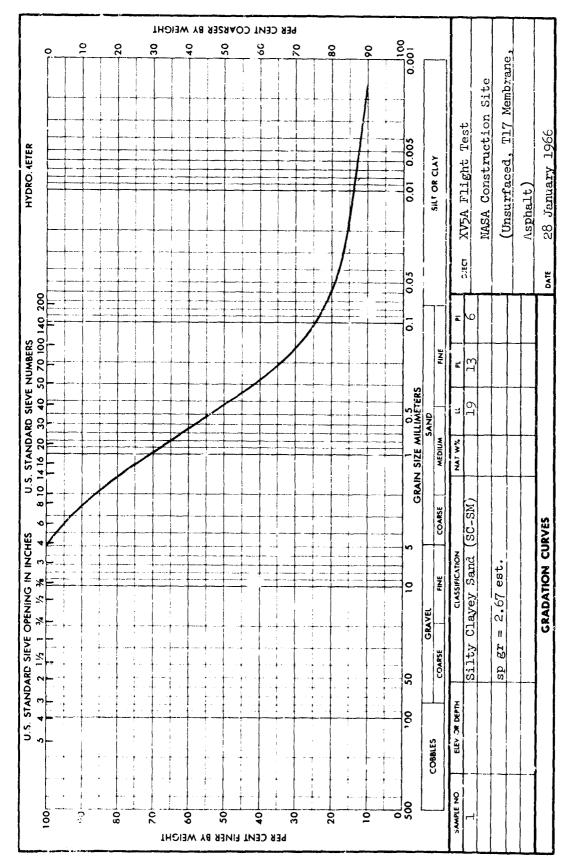
PLATE I

- 5. NASA construction site. This site is located about 1/2 mile northwest of the NASA Headquarters Building at Edwards AFB. (It was also used for tests on the prepared areas discussed later.) The NASA site had recently been used as a soil borrow area, and the top 12 to 18 in. of soil had been removed, including vegetation. The material classified as a silty, clayey sand (see plate 1), and in its moist, dense condition it exhibited far more than adequate soil bearing capacity. The XV5A landed successfully on this untreated site.

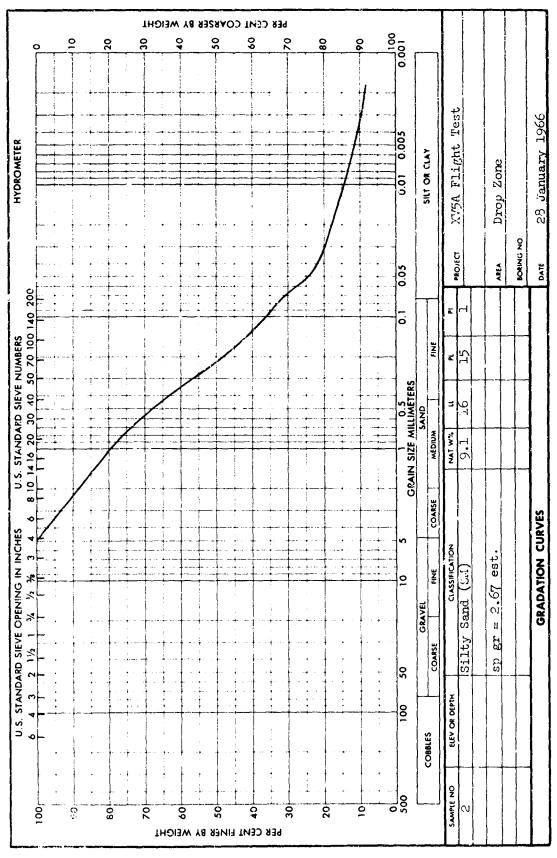
PLATE 2

- 6. Drop zone site. This site is located 3 to 4 miles west of the General Electric test facility at Edwards AFB. It is a large area of silty sand (see plate 2) that has been plowed and pulverized to cushion landings of parachutists. Although the XV5A had not operated at this site at the time that the Memorandum for Record* on which this report is based was prepared, it was predicted that the high moisture contents mentioned earlier would more significantly reduce erosion here than at any other site. However, it was also predicted that this site would undergo the most severe soil erosion in spite of its moisture content. Both of these predictions were based on the pulverized condition of the material in

conjunction with its silty character. The inadequate soil bearing capacity at this site made landing impossible, so the objective was to hover as low as possible. Operation of the XV5A, subsequent to the memorandum, fulfilled the above predictions and the dust made the possibility of a landing highly unlikely.

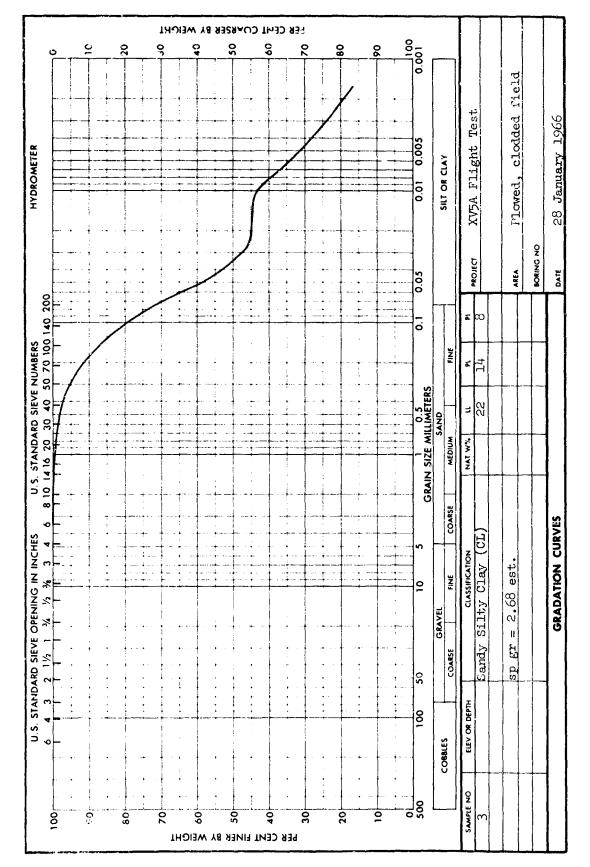
PLATE 3

- 7. Plowed, clodded field site. This site is located about 10 miles southwest of the main area at Edwards AFB. It is a barren, cultivated area that is normally used for agricultural purposes. The material classified as a sandy, silty clay (see plate 3). The site was very wet and had 2- to 4-in.-diameter earth clods covering the surface. Due to the low soil bearing capacity and the irregular surface, the XV5A did not land; however, it descended to a height of about 4 ft, with no erosion problems.

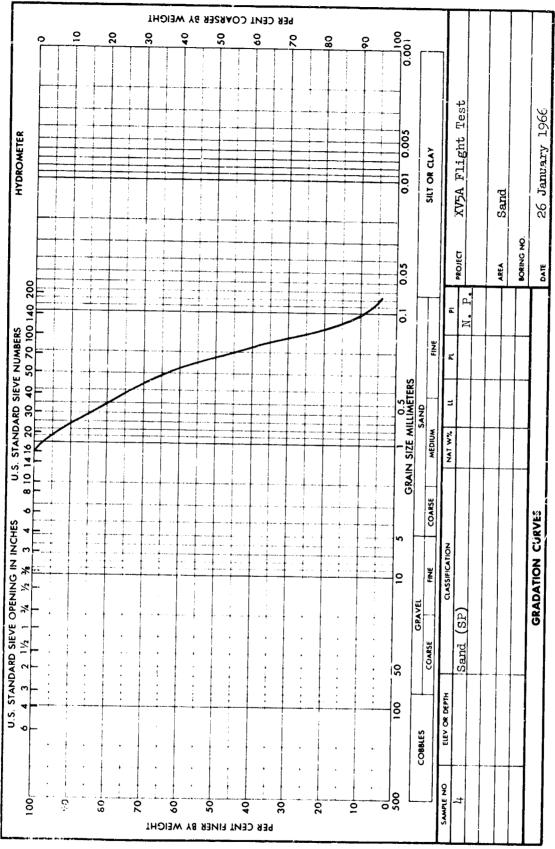
PLATE 4

- 8. Sand site. The sand site is located about 8 miles southeast of the main base area at Edwards AFB and is adjacent to the south access road. It is a very uniform sand area (plate 4) with a minimum of vegetation. Although this site was not used, it was almost certain that the XV5A would be unable to land due to severe erosion. The uniform, loose condition of this sand (as with any uniform sand) makes it especially susceptible to continued erosion.

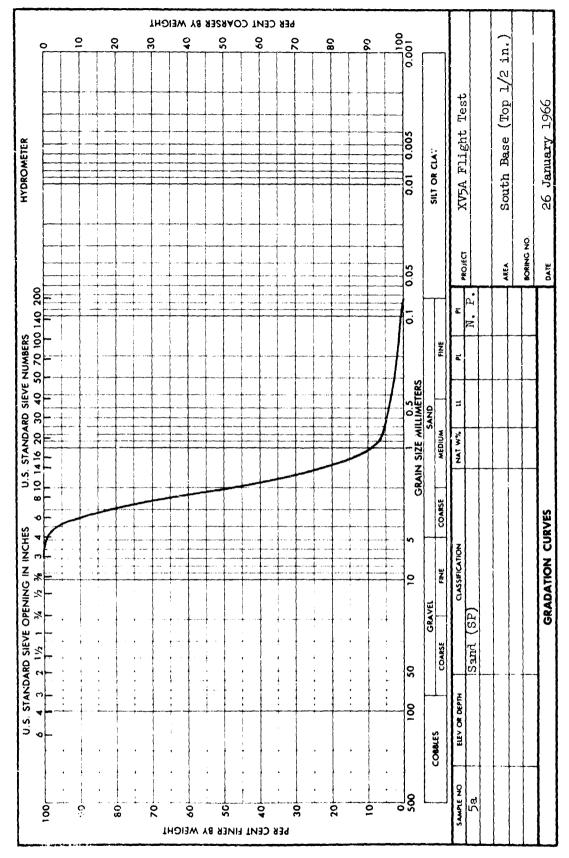
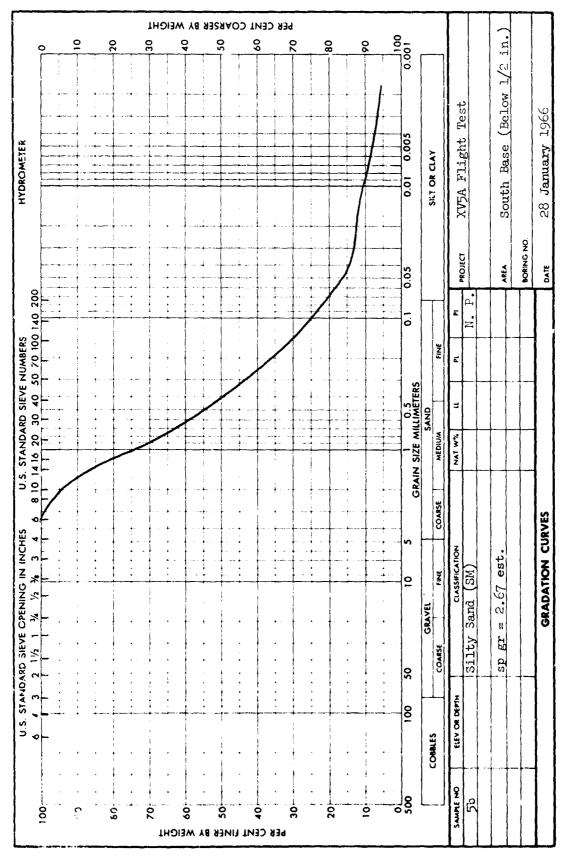
- 9. South base site. This site is located on the overrun area of the south base runway about 2 miles south of the main base. The soil characteristics are shown in two parts on plates 5 and 6 due to the very marked difference in composition. The top 1/2 in. of material at this site consists of a uniform, coarse-to-medium sand, and the material below this is a silty sand similar to that in the drop zone. The XV5A made a successful landing at this site with a minimum of erosion.

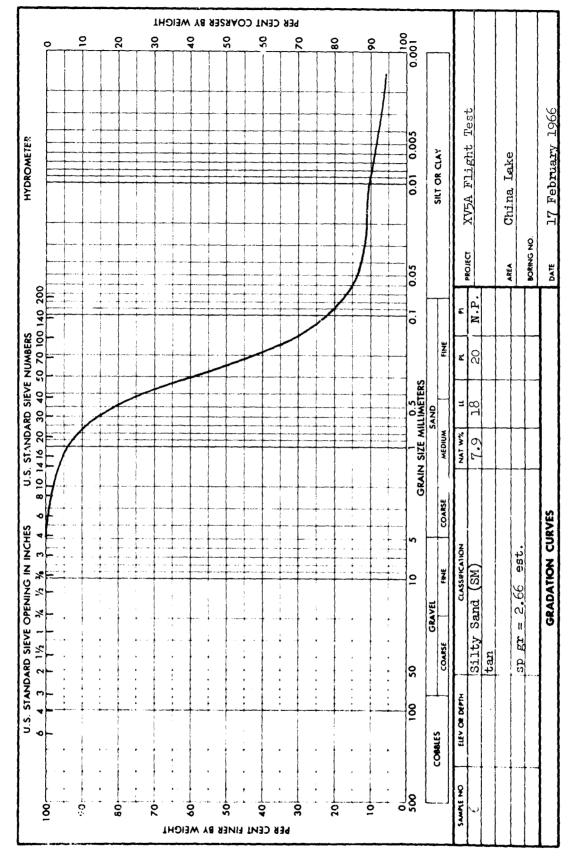
PLATE 7

- 10. China Lake sod site. The sod site is located on the golf driving range at the China Lake Naval Air Facility about 80 miles north of Edwards AFB. The area was fully covered with bermuda grass and bluegrass sod. This sod was firmly rooted in a 1-in.-thick layer of fibrous, organic silt underlain by silty sand; the characteristics of the base material are shown in plate 7. The XV5A operated with no difficulty, and there was no damage to the site whatsoever.

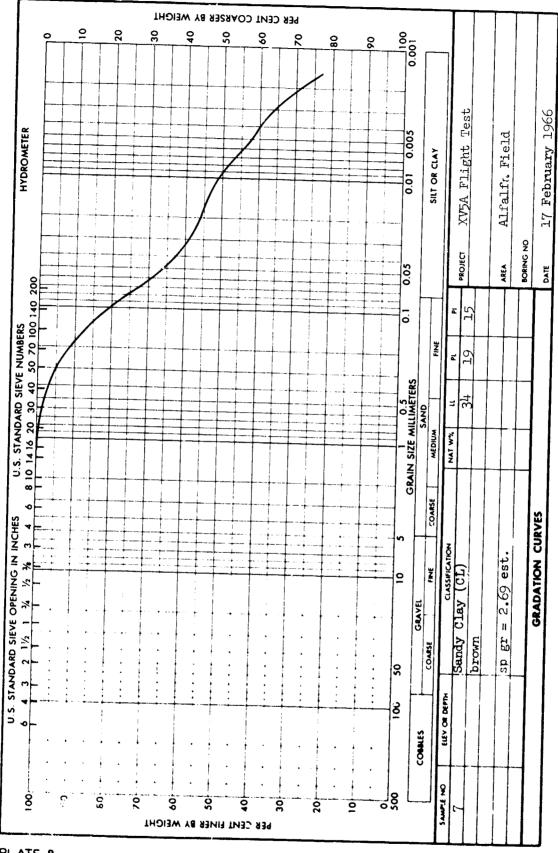
PLATE 8

southwest of the main area at Edwards AFB. A mowed stubble, about 2 in. high, covered about 60 percent of the area. The soil classified as a lean clay (plate 8), and in its very moist condition, it resisted erosion during a landing by the XV5A. The soil bearing capacity was believed to be inadequate to support the XV5A, so the nose gear was held off the ground and the aircraft remained essentially in a hover. Each main gear, supporting an estimated 2000 lb, made a 1/2-in.-deep rut in the soil surface.
